Chapel Hill Elementary School Traffic Study

Douglas County, Georgia

**Prepared for:
Douglas County**

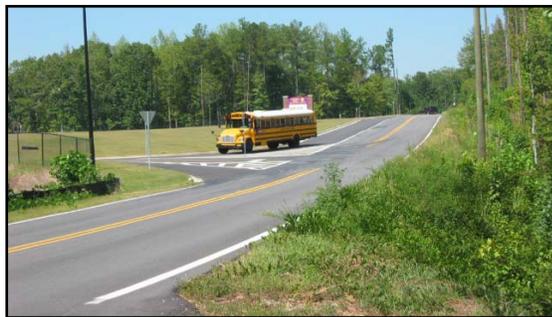
*Chapel Hill Elementary School
South Driveway*

Chapel Hill Elementary School has two access driveways to Coursey Lake Road. The southern driveway provides access for school buses only, while the northern driveway is dedicated to teacher/visitor parking and passenger vehicles dropping off and picking up students. The northern driveway is located at the top of a crest vertical curve, which limits sight distance for southbound vehicles on Coursey Lake Road. Curb and gutter is present along the school property. Southbound right turn lanes are present at the north and south

driveways. In addition to painted channelized right turn lanes for outbound vehicles, each driveway is stop-controlled with right-turn yield.

An advanced 25 mph school zone warning sign (S4-5) precedes a school zone ahead sign (S1-1 and W16-9p). A school zone speed limit 25 mph sign with hours of enforcement supplemental sign (S4-3, R2-1, and S4-1) is posted at the beginning of the school zone, approximately 415 feet south of the southern school driveway and 300 feet north of the northern school driveway. "SCHOOL" pavement marking are located at the beginning of the school zone in each direction.

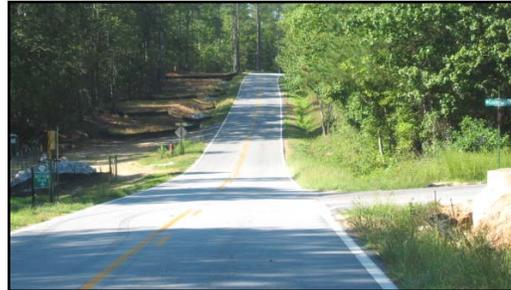
*Westbound Dorsett Shoals Road at
Coursey Lake Road*

Dorsett Shoals Road is a two-lane local roadway with a 40 mph speed limit at the intersection with Coursey Lake Road. It provides a connection east to Chapel Hill Road and west to Bill Arp Road. The Dorsett Shoals Road approaches to the intersection consist of 10.5 foot lanes with no curb and gutter and grass shoulders. Dorsett Shoals Road has the right-of-way at the intersection and therefore no traffic control devices regulate the through movement. The eastbound approach has an intersection warning sign (W2-2) 250 feet from the intersection. No warning signs are present on the westbound approach.

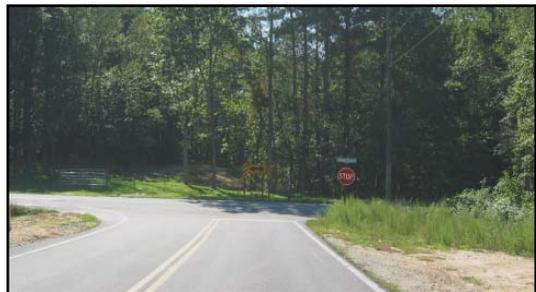
*Southbound Coursey Lake Road at
Dorsett Shoals Road*

The Coursey Lake Road approach forms a “T” intersection with 11.5 feet wide lanes. Coursey Lake Road is stop controlled at the intersection with no turn bays provided. Dual indicated trucks use lower gear (W7-2b) and 13% grade (W7-1b) sign assemblies are located southbound 930 feet prior to the intersection, followed by a left curve warning sign (W1-2), and dual indicated stop ahead warning signs (W3-1). Three left chevron signs (W1-8) warn drivers as they traverse the curve before stopping at the bottom of the hill. Along the southern side of Dorsett Shoals Road, there is a two directional large arrow sign (W1-7) and object marker signs (OM-3).

Coursey Lake Road approach to the Dorsett Shoals Road intersection is on a 13 percent downward grade. Although the approach to the intersection consists of vertical and horizontal curves, there are only two collisions reported at this location; one angled and one equipment failure unfortunately resulting in a fatality.

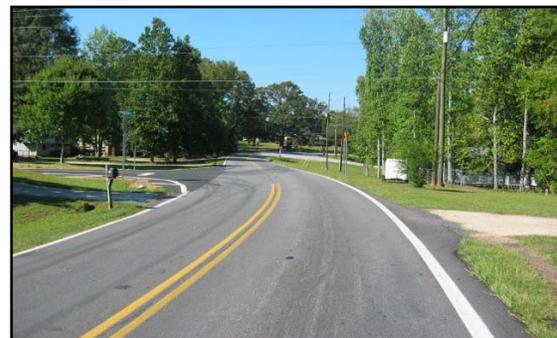
*Westbound Central Church Road at
Coursey Lake Road*

Central Church Road is a two-lane collector that connects Chapel Hill Road with Stewart Mill Road. The roadway is oriented to the east-west within the study area with a speed limit of 45 mph. Travel lanes on Central Church Road vary in width from 10.5 feet to 12 feet with no curb and gutter and narrow grass shoulders. Central Church Road has right-of-way at the intersection and therefore no traffic control devices regulate the through movement. An intersection warning sign (W2-2) with a supplemental road name assembly is located westbound in advance of the

intersection. Additionally, dual indicated westbound stop ahead warning signs are located east of Coursey Lake Road that apply to the Central Church Road at Yancey Road intersection west of Coursey Lake Road.

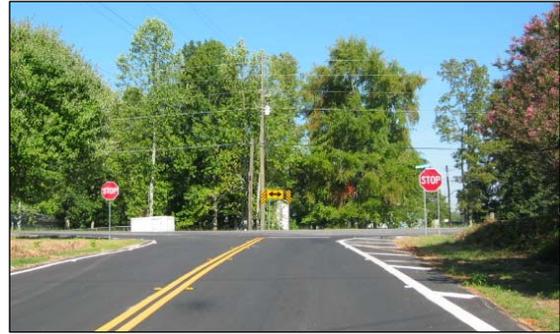
Northbound Coursey Lake Road at Central Church Road

The Coursey Lake Road approach forms a “T” intersection with 12-foot northbound and 13-foot southbound lanes. The posted speed limit is 35 mph at the intersection. Northbound Coursey Lake Road has dual indicated stop ahead warning signs posted 375 feet from the intersection. Dual indicated stop signs are located at the intersection, and a two directional large arrow sign (W1-7) and object marker signs (OM-3) are located north of the intersection.

The northbound Coursey Lake Road sight distance looking east onto Central Church Road was field measured at approximately 330-feet. Current American Association of State Highway and Transportation Officials (AASHTO) “A Policy on Geometric Design of Highways and Streets, 5th Edition” (2004) design guidelines indicate that the existing left turn departure sight distance does not meet current standard of 500-feet.

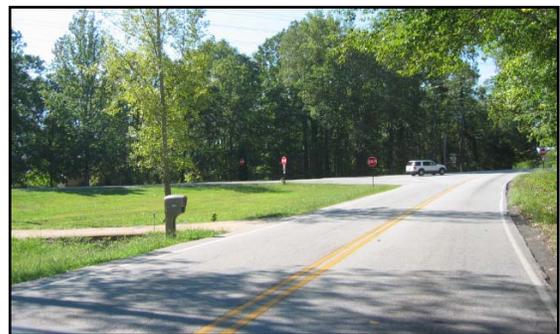
Southbound Yancey Road at Central Church Road

Yancey Road is a two-lane local roadway with a speed limit of 35 mph that provides connection between Stewart Mill Road to the north and Dorsett Shoals Road to the south. Lane widths are 10.5 feet and 11.5 feet for the northbound and southbound approaches, respectively. No curb and gutter is present at the intersection.

The southbound Yancey Road approach intersects Central Church Road at a 40-degree skewed angle, resulting in a poor alignment of the intersection. The skewed alignment and the turn radii necessary to accommodate vehicles on Central Church Road, results in large areas of unmarked pavement and poor guidance through the intersection.

The skewed alignment of the northbound and southbound Yancey Road approaches at the intersection with Central Church Road results in a large area of unused pavement needed to accommodate adequate turn radius, which results in poor guidance for vehicles traversing the intersection. To improve the operation of the intersection, the following improvement actions are recommended (Refer to Figure 16):

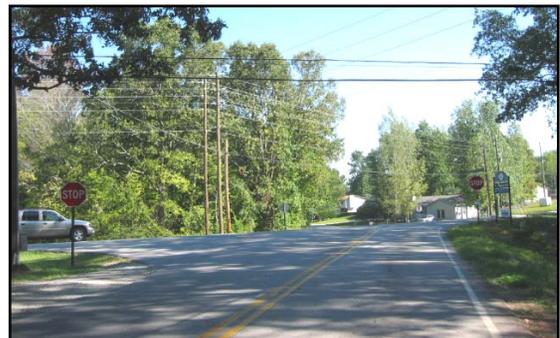
Northbound Yancey Road at Central Church Road

The intersection operates under all-way stop condition, and dual indicated stop signs (R1-1) are present on all approaches. The Central Church Road eastbound approach has dual indicated stop ahead signs (W3-1) posted approximately 665-feet from the intersection, east of Coursey Lake Road.

Dual indicated stop ahead signs (W3-1) are also posted approximately 450-feet from the intersection on the northbound and westbound approaches and 700-feet on the southbound approach.

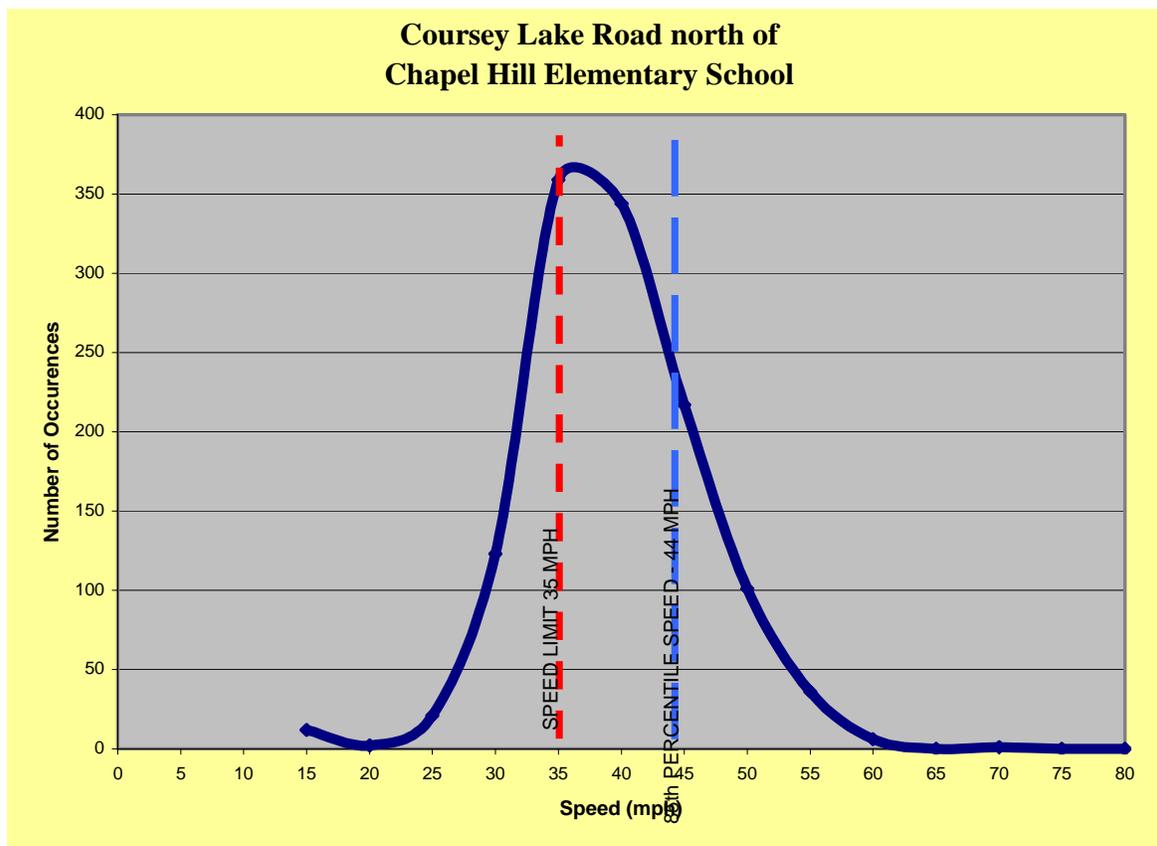
Figure 8
Speed Profile

Figure 8 illustrates the number of occurrences a speed limit was surpassed during a 24-hour period. As the figure shows, the speed limit was exceeded by 58 percent of the vehicles at the Coursey Lake Road location.

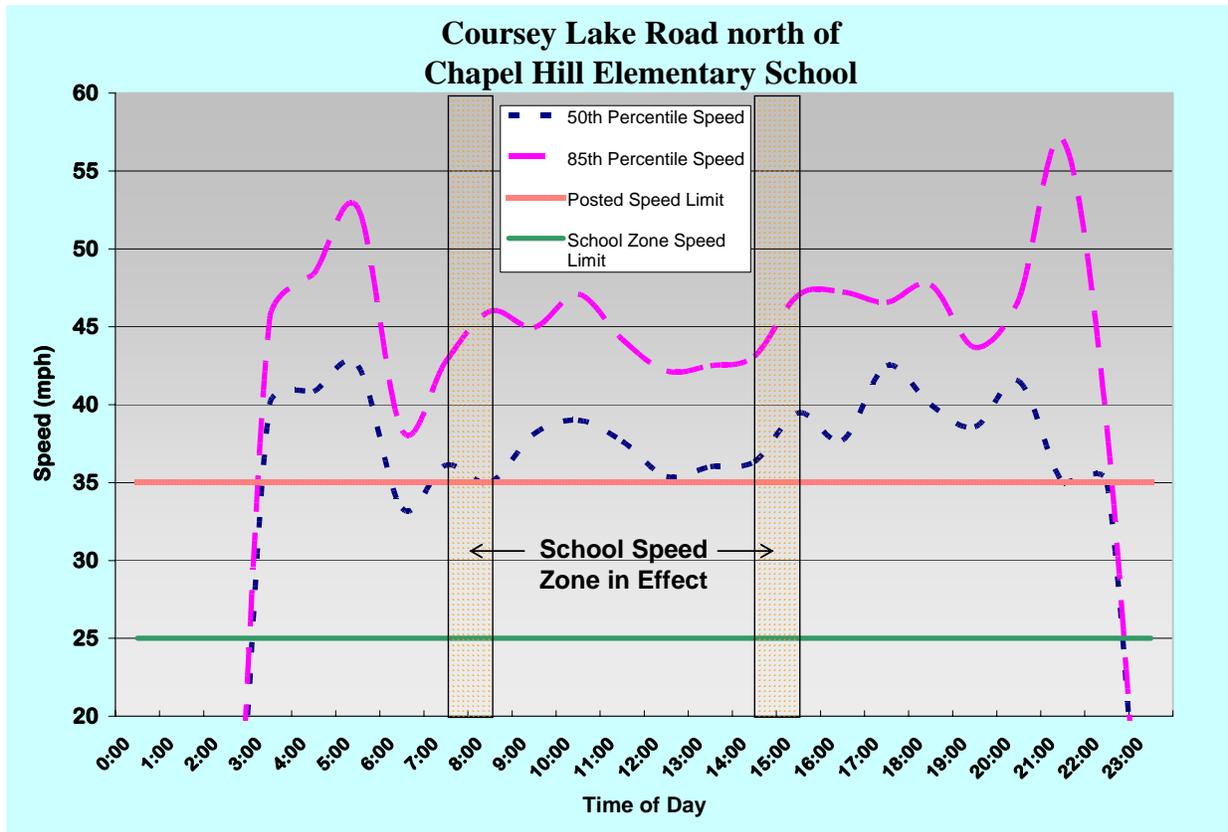
Figure 9
Speed Variance

The posted speed limit along Coursey Lake Road is 35 mph, but during Chapel Hill Elementary School arrival and dismissal times the designated school zone speed limit is reduced to 25 mph from 7:30 to 8:30 AM and from 2:30 to 3:30 PM. Although recorded vehicle travel speeds were reduced when the 25 mph speed limit is in effect, most vehicles continue to exceed the regularly posted speed limit of 35 mph. Figure 9 illustrates the 50th and 85th percentile speeds during a 24-hour period.

The 85th percentile distribution of observed speeds is used to measure the speed at which most drivers travel during free-flow conditions at a particular location. The average daily directional 85th percentile speed of the southbound and northbound traffic on Coursey Lake Road was 44 and 43 mph, respectively.
